FURTHER SITE INVESTIGATION

“Sherman Park Parcel B”

Further Site Investigation Project

HEA No. 5145-17-05

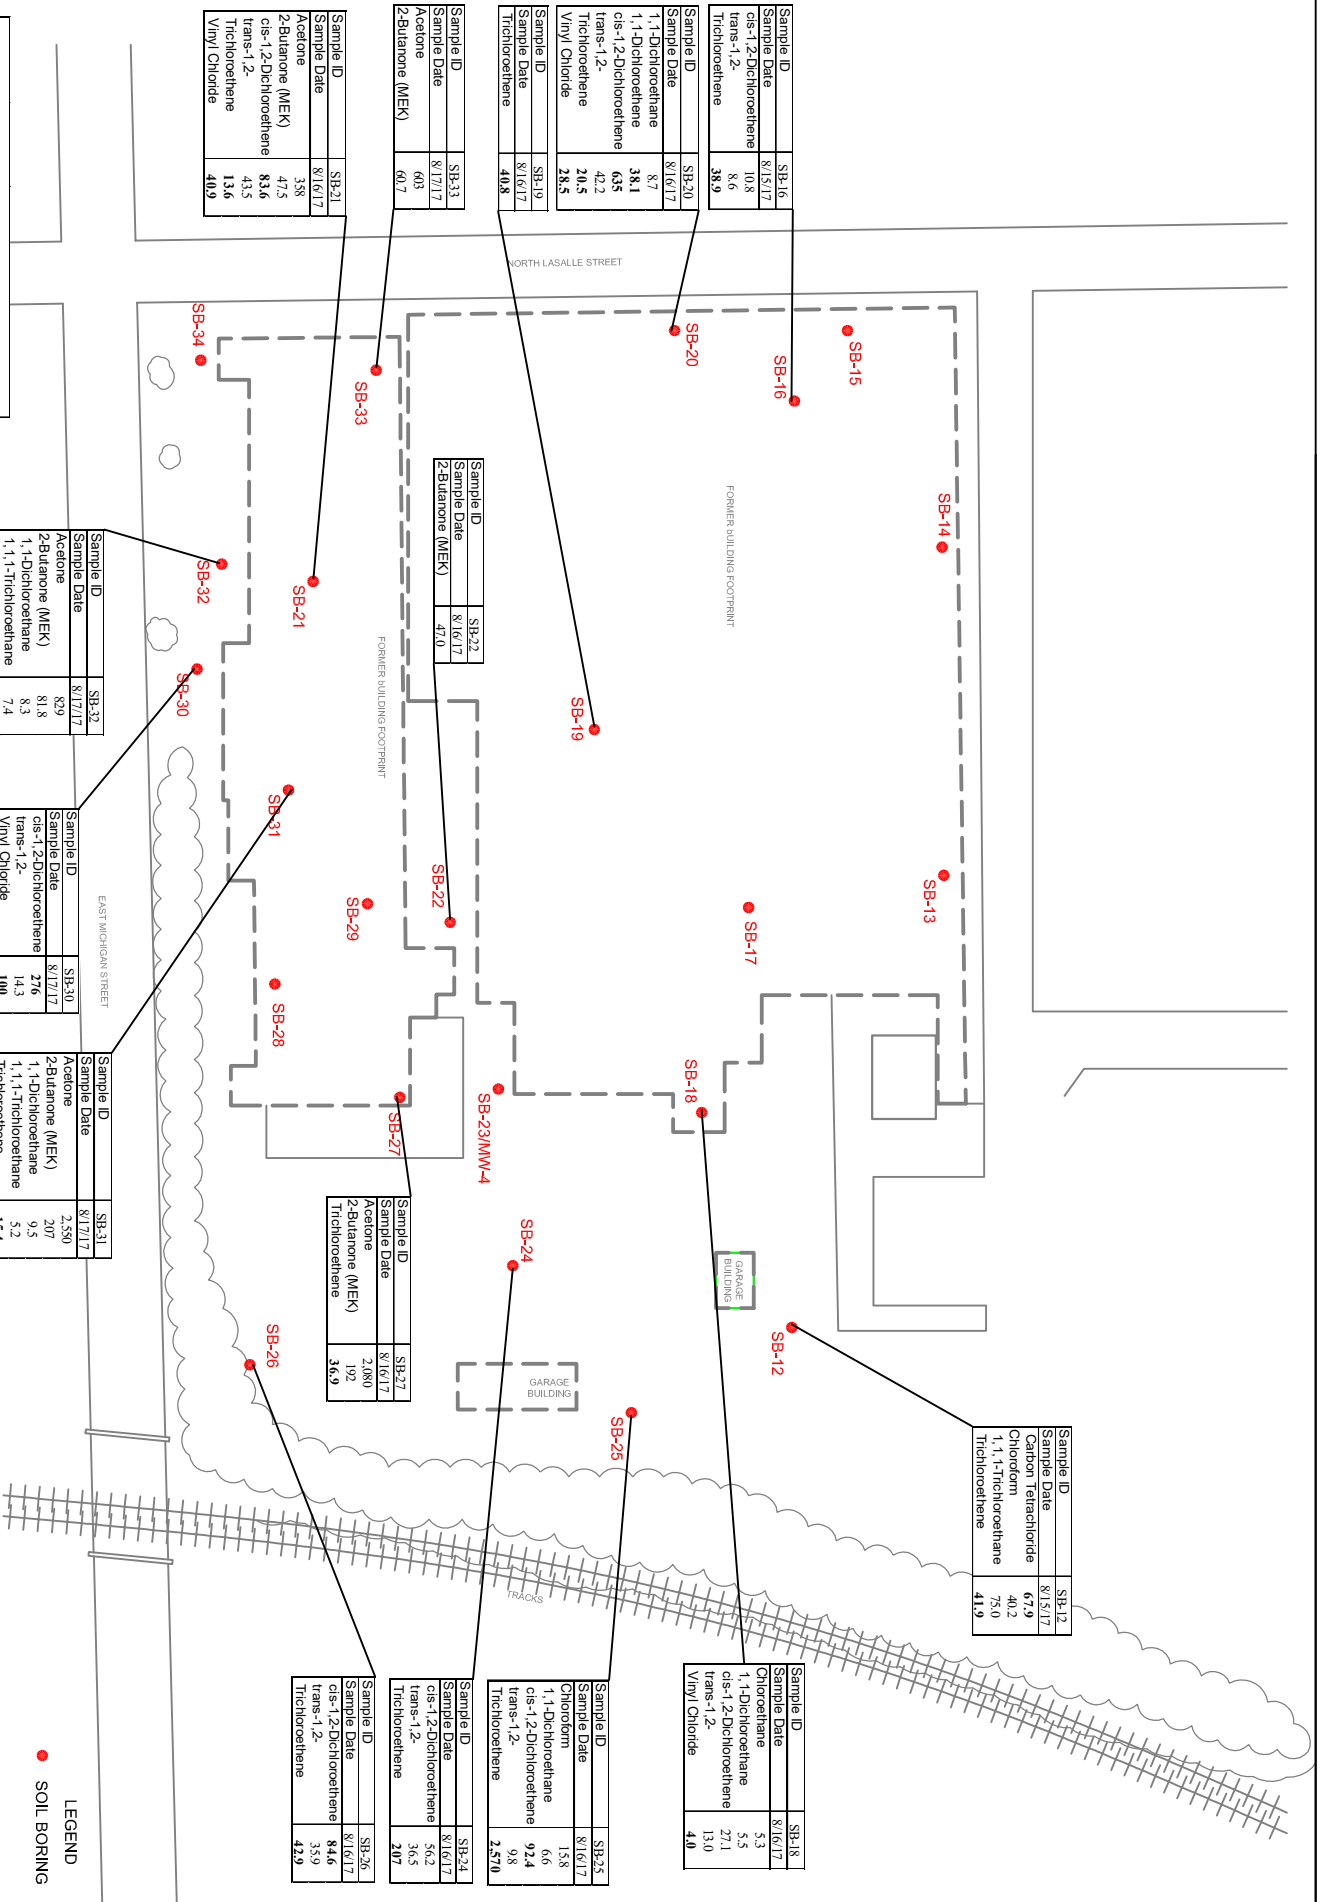
FIGURE 16
 PRESENT VOCS IN WATER ANALYTICAL MAP
 PARCEL B
 FORMER THOMSON CONSUMER ELECTRONICS / FORMER RCA / FORMER GE
 SHERMAN PARK FACILITY
 3324 EAST MICHIGAN STREET
 INDIANAPOLIS, INDIANA 46201

Groundwater impacts that exceeded IDEM RCG RSLs for carbon tetrachloride were encountered in one soil boring (SB-12). Additionally, groundwater impacts that exceeded IDEM RCG RSLs for 1,1-dichloroethene were encountered in one soil boring (SB-20).

Groundwater impacts for cis-1,2-dichloroethene were encountered in five soil borings (SB-20, SB-21, SB-25, SB-26 and SB-30) and groundwater impacts for TCE were encountered in 11 soil borings (SB-12, SB-16, SB-19 through SB-21, SB-24 through SB-27, SB-31 and SB-32) that exceeded IDEM RCG RSLs. Additionally, groundwater impacts that exceeded IDEM RCG RSLs for vinyl chloride were encountered in four soil borings (SB-18, SB-20, SB-21 and SB-30).

No other VOC impacts were encountered that exceeded IDEM RCG RSLs. VOCs in groundwater analytical results are summarized in Table 5 and depicted on Figure 16. The laboratory certificate of analysis is included in Appendix D.
